# CERTIFIED LEAKAGE REPORT

## Duct sealing performed for:

Aeroseal Case ID: 7748

Hardware: HomeSeal Advance

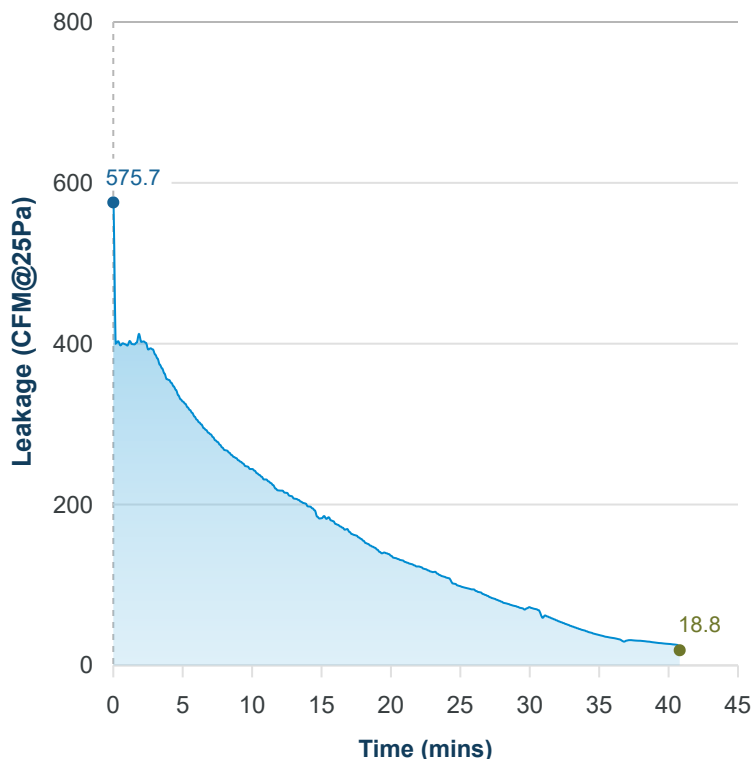
Duct leakage results are calculated in CFM calculated at a STANDARD OPERATING PRESSURE of 25 Pa.

| | Initial | Final |
| CFM@25Pa | 575.69 | 18.84 |
| CFM/100ft <sup>2</sup> @25Pa | 21.32 | 0.70 |
| Equivalent Hole Size (Sq.In) | 108.76 | 3.56 |
| % System Capacity | 36.0 % | 1.2 % |
